5.5 Wind Control Devices with suppression WDF 5

The fifth experiment in the series was conducted to examine the impact of wind on the structure fire and quantify the impact of the small wind control device. It also examined the impact of a 30 gpm water flow to be applied in conjunction with the WCD deployment. The experimental preparations were made as described in Section 4. The fan speed used in this experiment was 1500 RPM, which provided a 3.0 m/s to 4.0 m/s (7 mph to 9 mph) wind speed at the window opening. A trash container fuel package was ignited remotely with an electric match to start the experiment at Time = 0 s. A time line of the experiment is presented in Table 5.5-1. The results for the experiment are presented in the following sections: observations, heat release rate, temperature, heat flux, pressure, velocity, and gas concentrations. An uncertainty range marker is included in each graph.

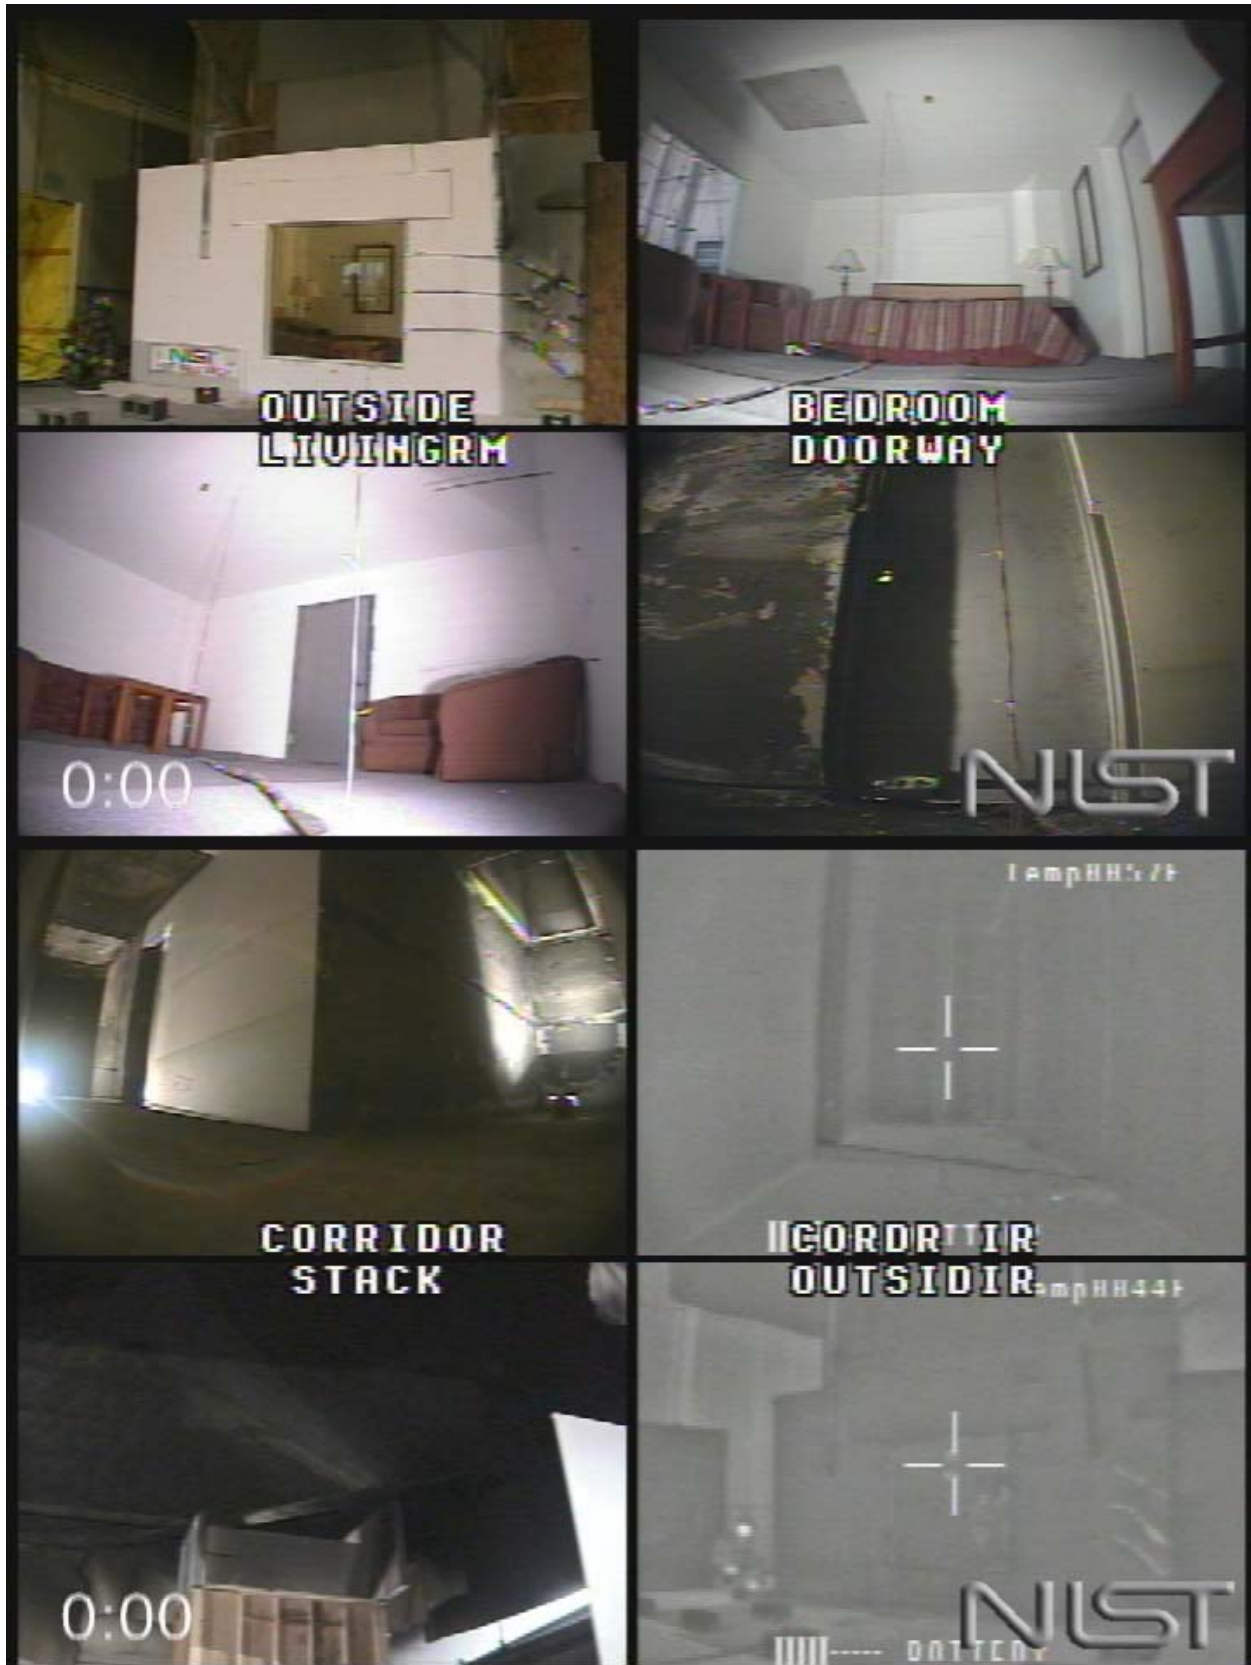
Figure 5.7.1-1. Experiment 7, ignition.

Figure 5.7.1-1 through Figure 5.7.1-13 present sets of eight images, one from each camera position, at a given time, from the time of ignition to 550 s after ignition. Each image view is labeled. Figure 5.7.1-1 shows the conditions at the time of ignition. At this point, the six video views are clear and unobstructed. However, the thermal images provide limited thermal contrast, because the surfaces in the view were at nearly equal temperature.

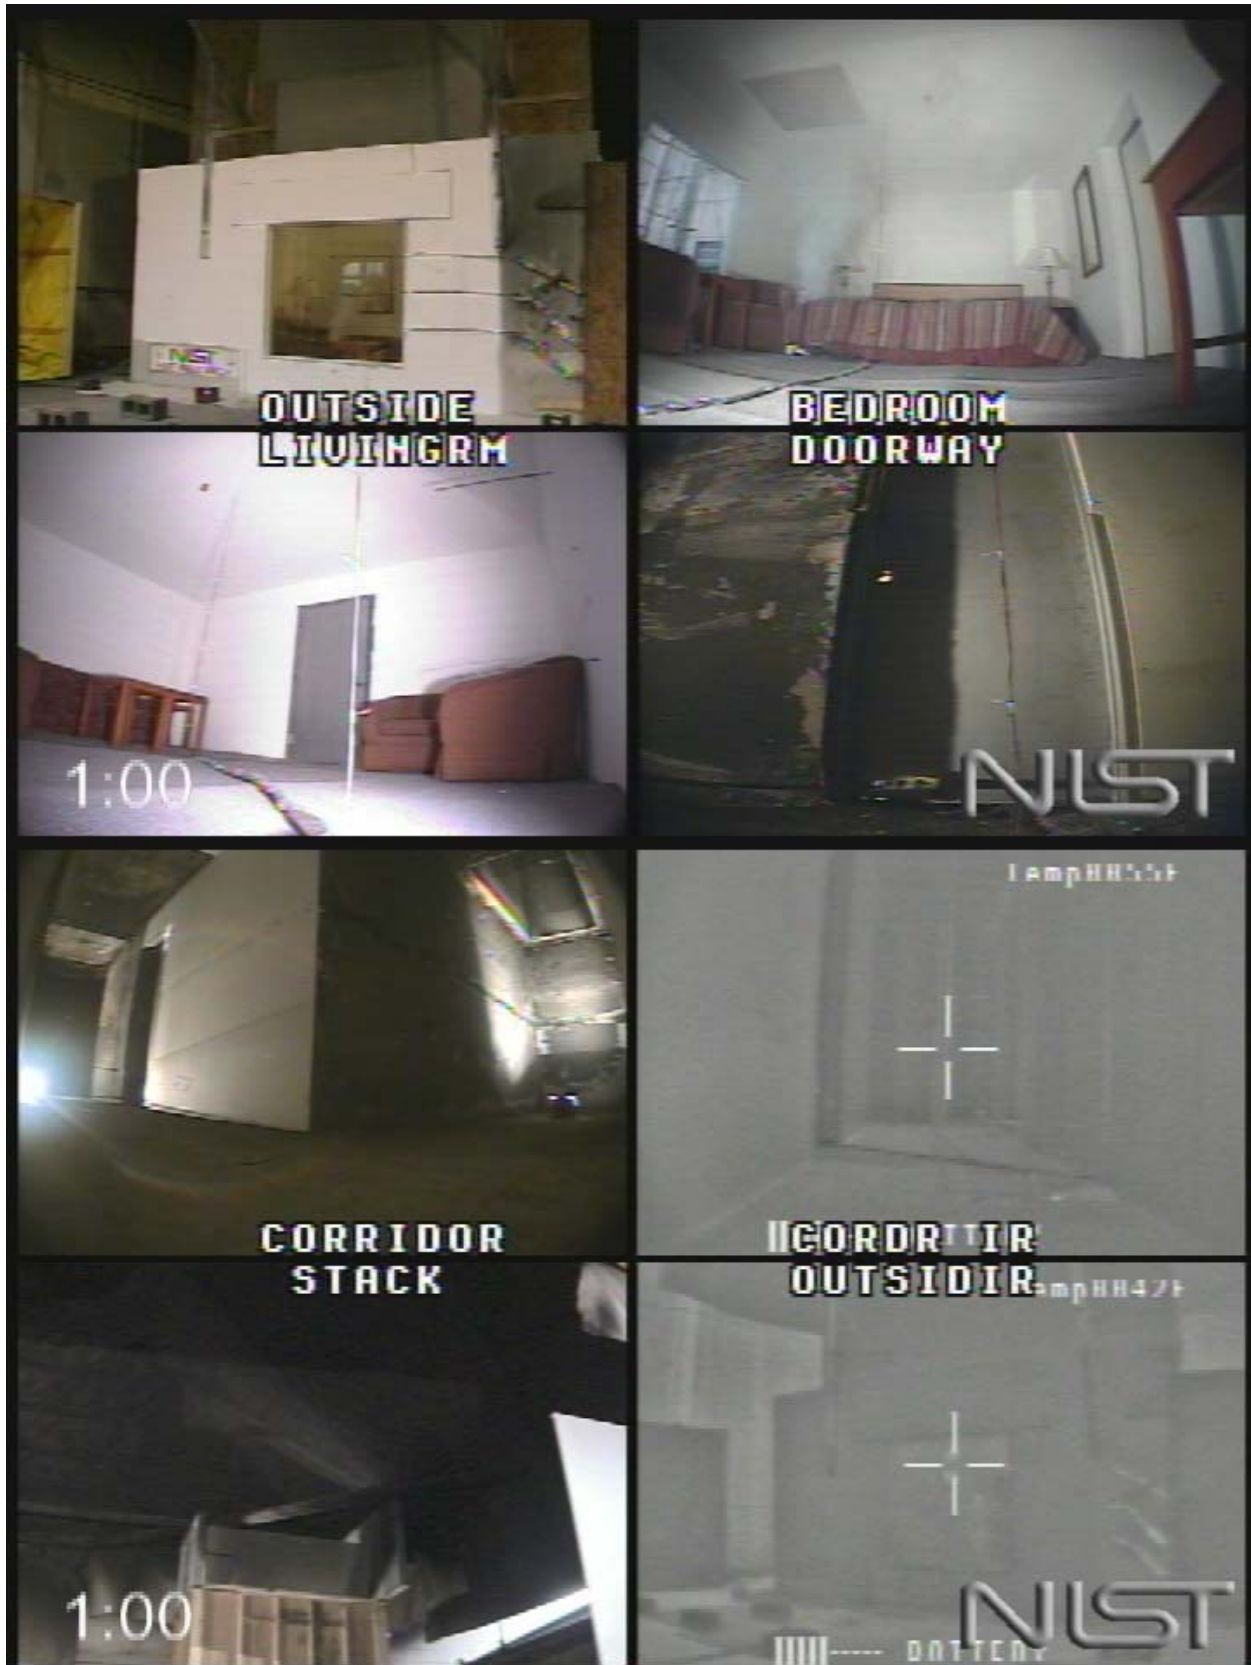
Figure 5.7.1-2. Experiment 7, 60 s after ignition.

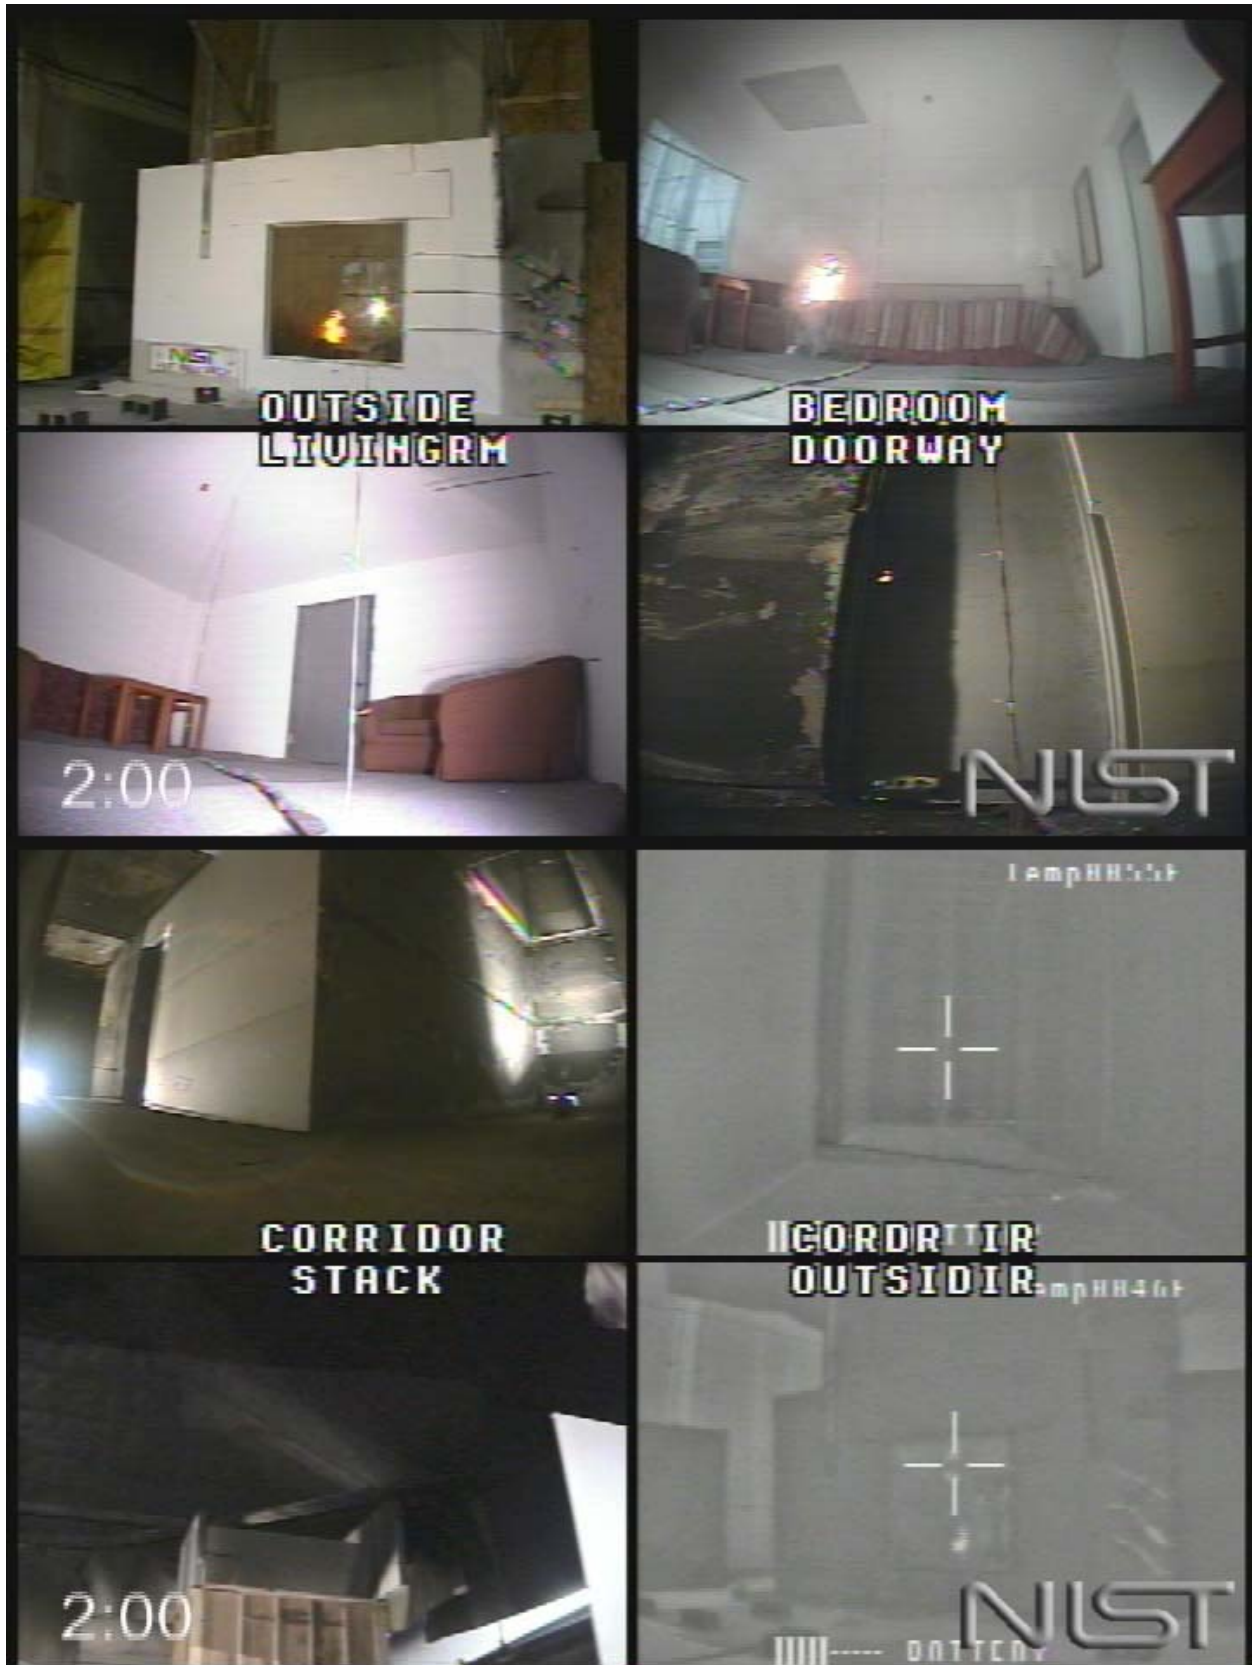
Figure 5.7.1-3. Experiment 7, 120 s after ignition.

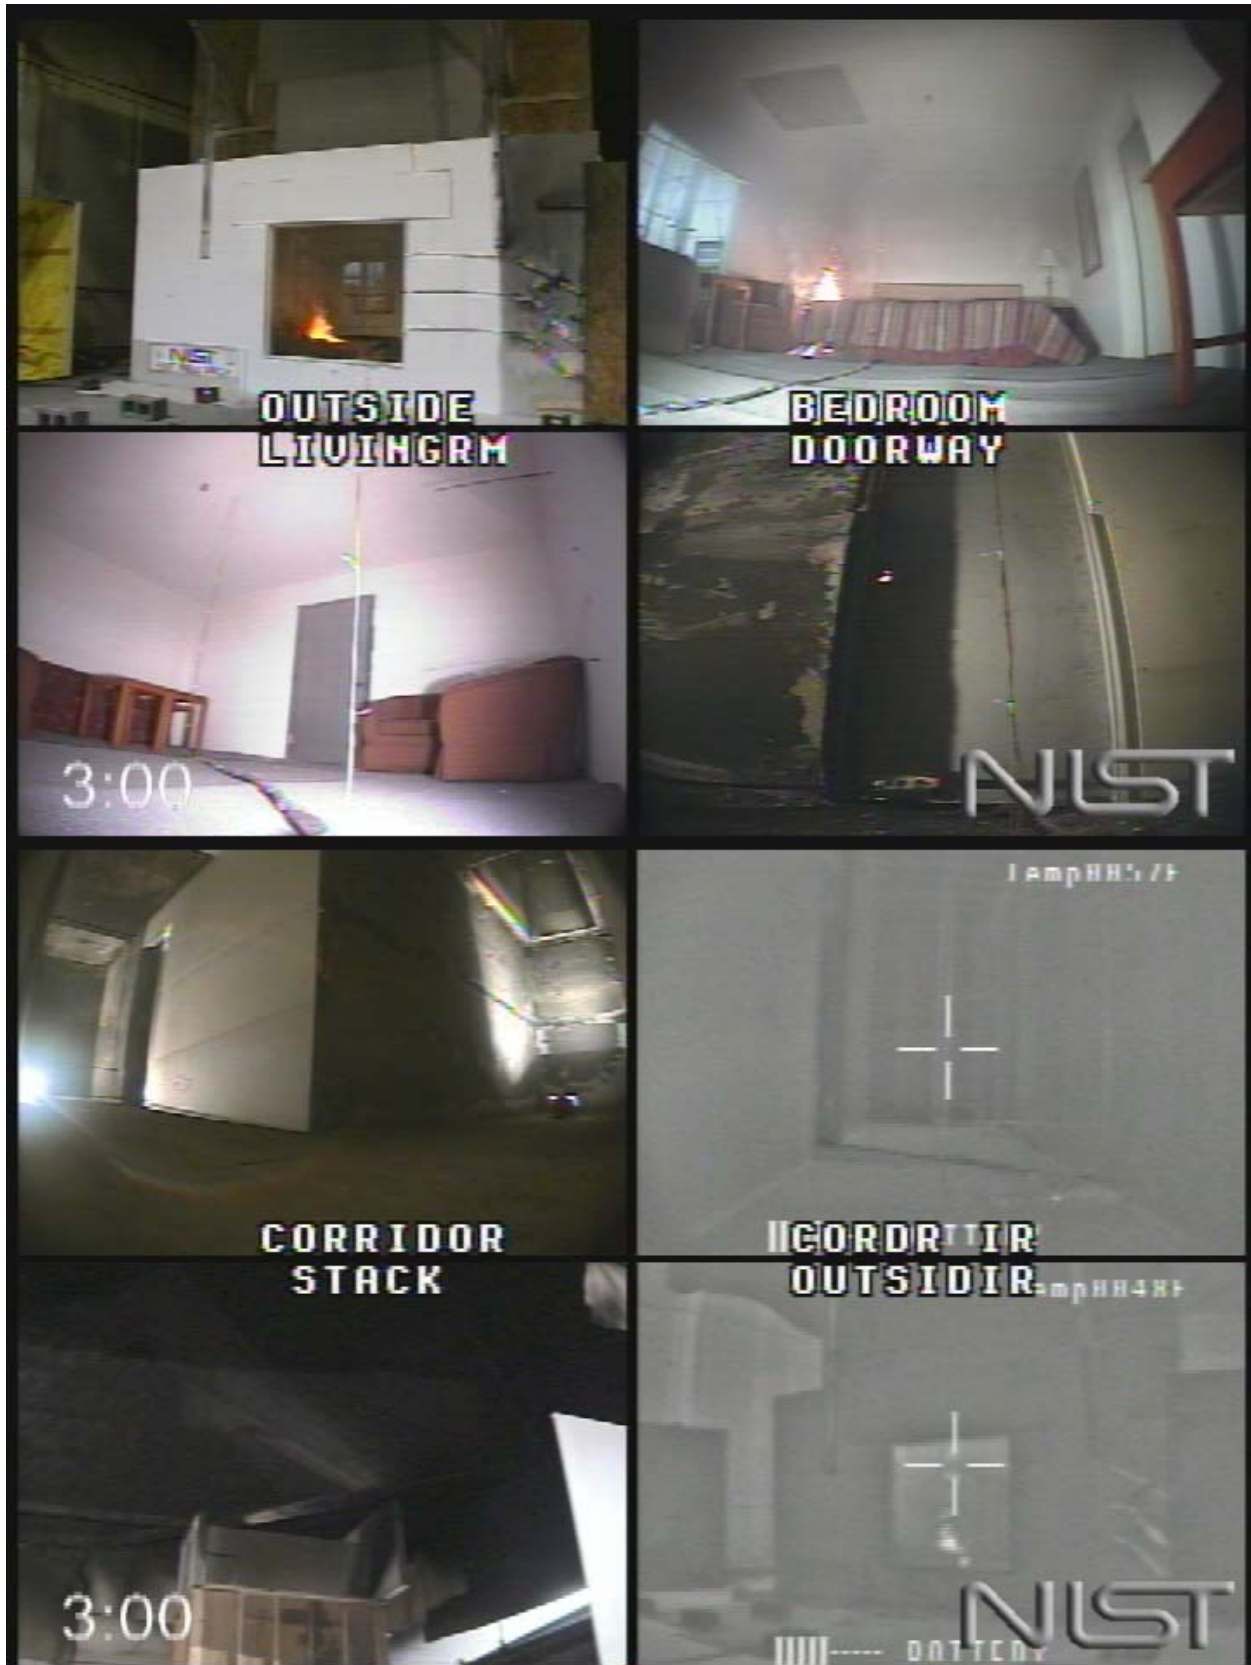
Figure 5.7.1-4. Experiment 7, 180 s after ignition.

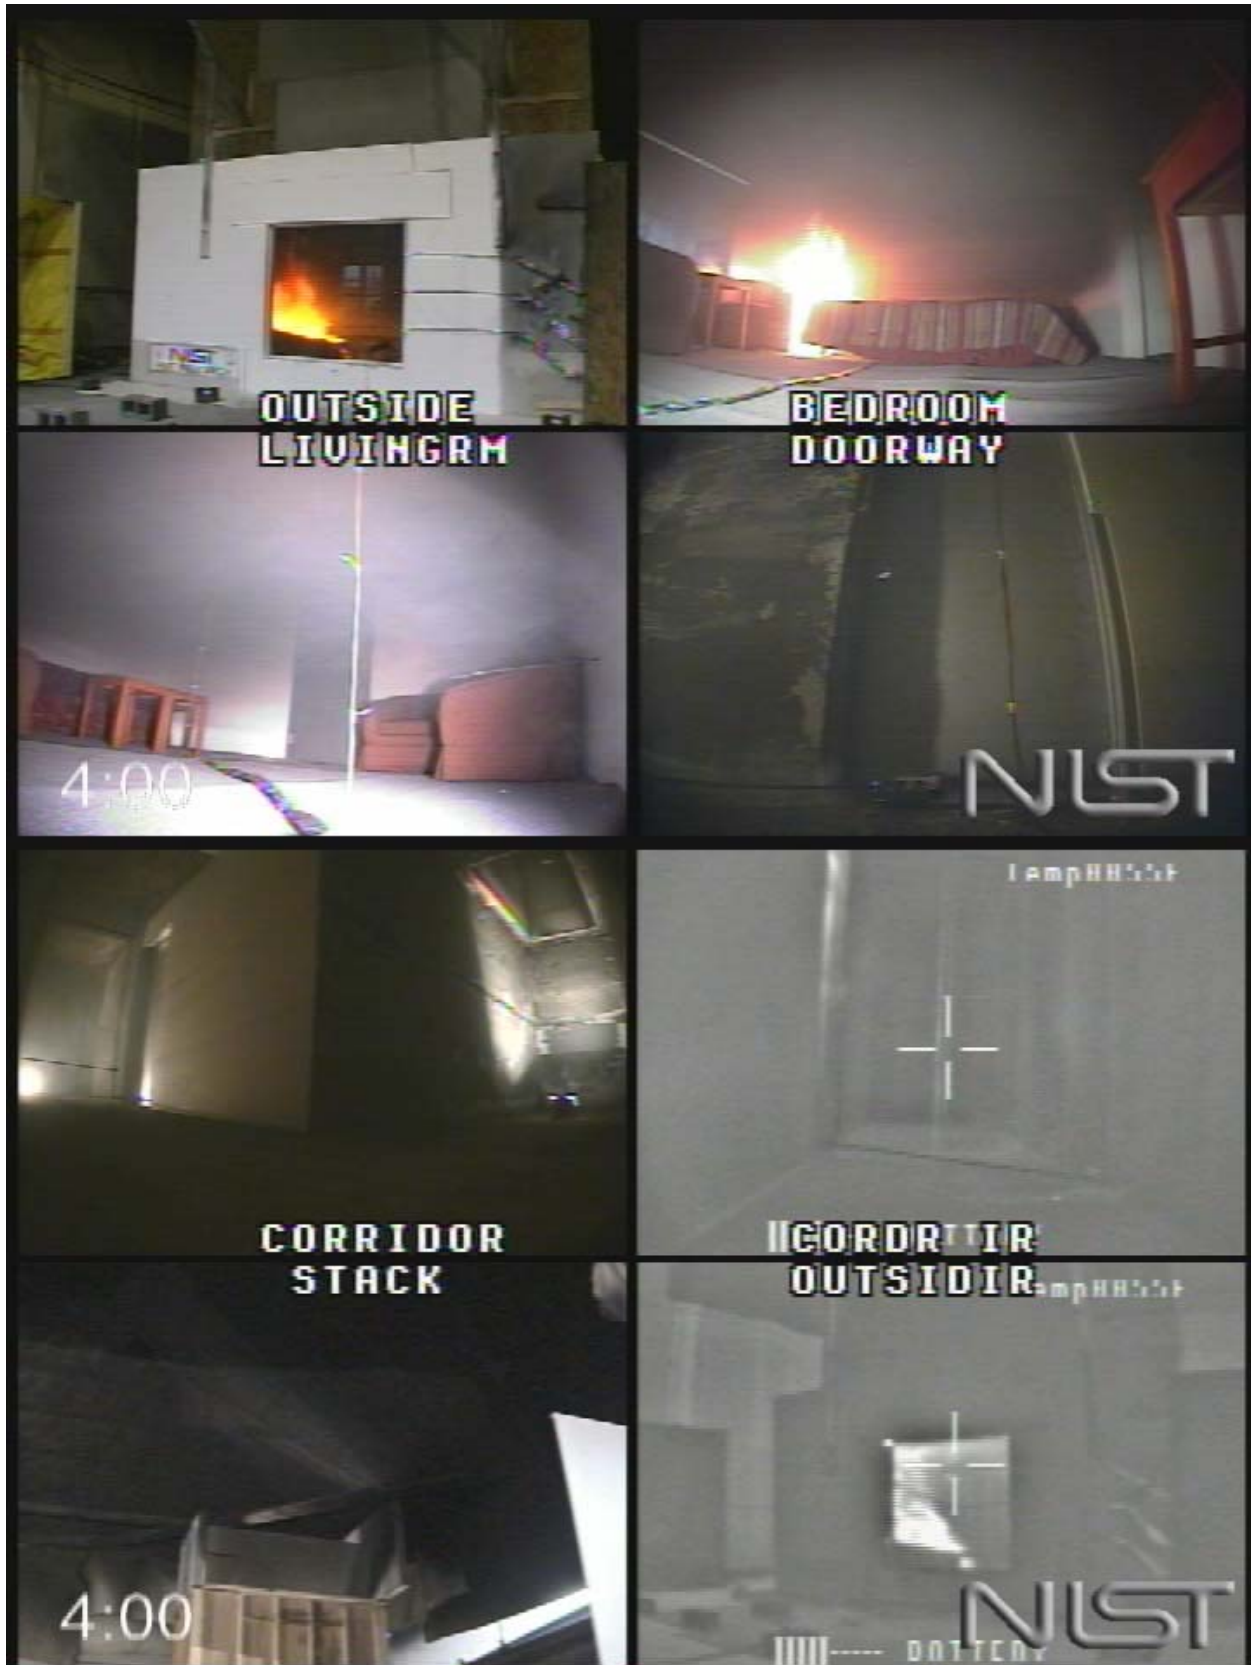
Figure 5.7.1-5. Experiment 7, 240 s after ignition.

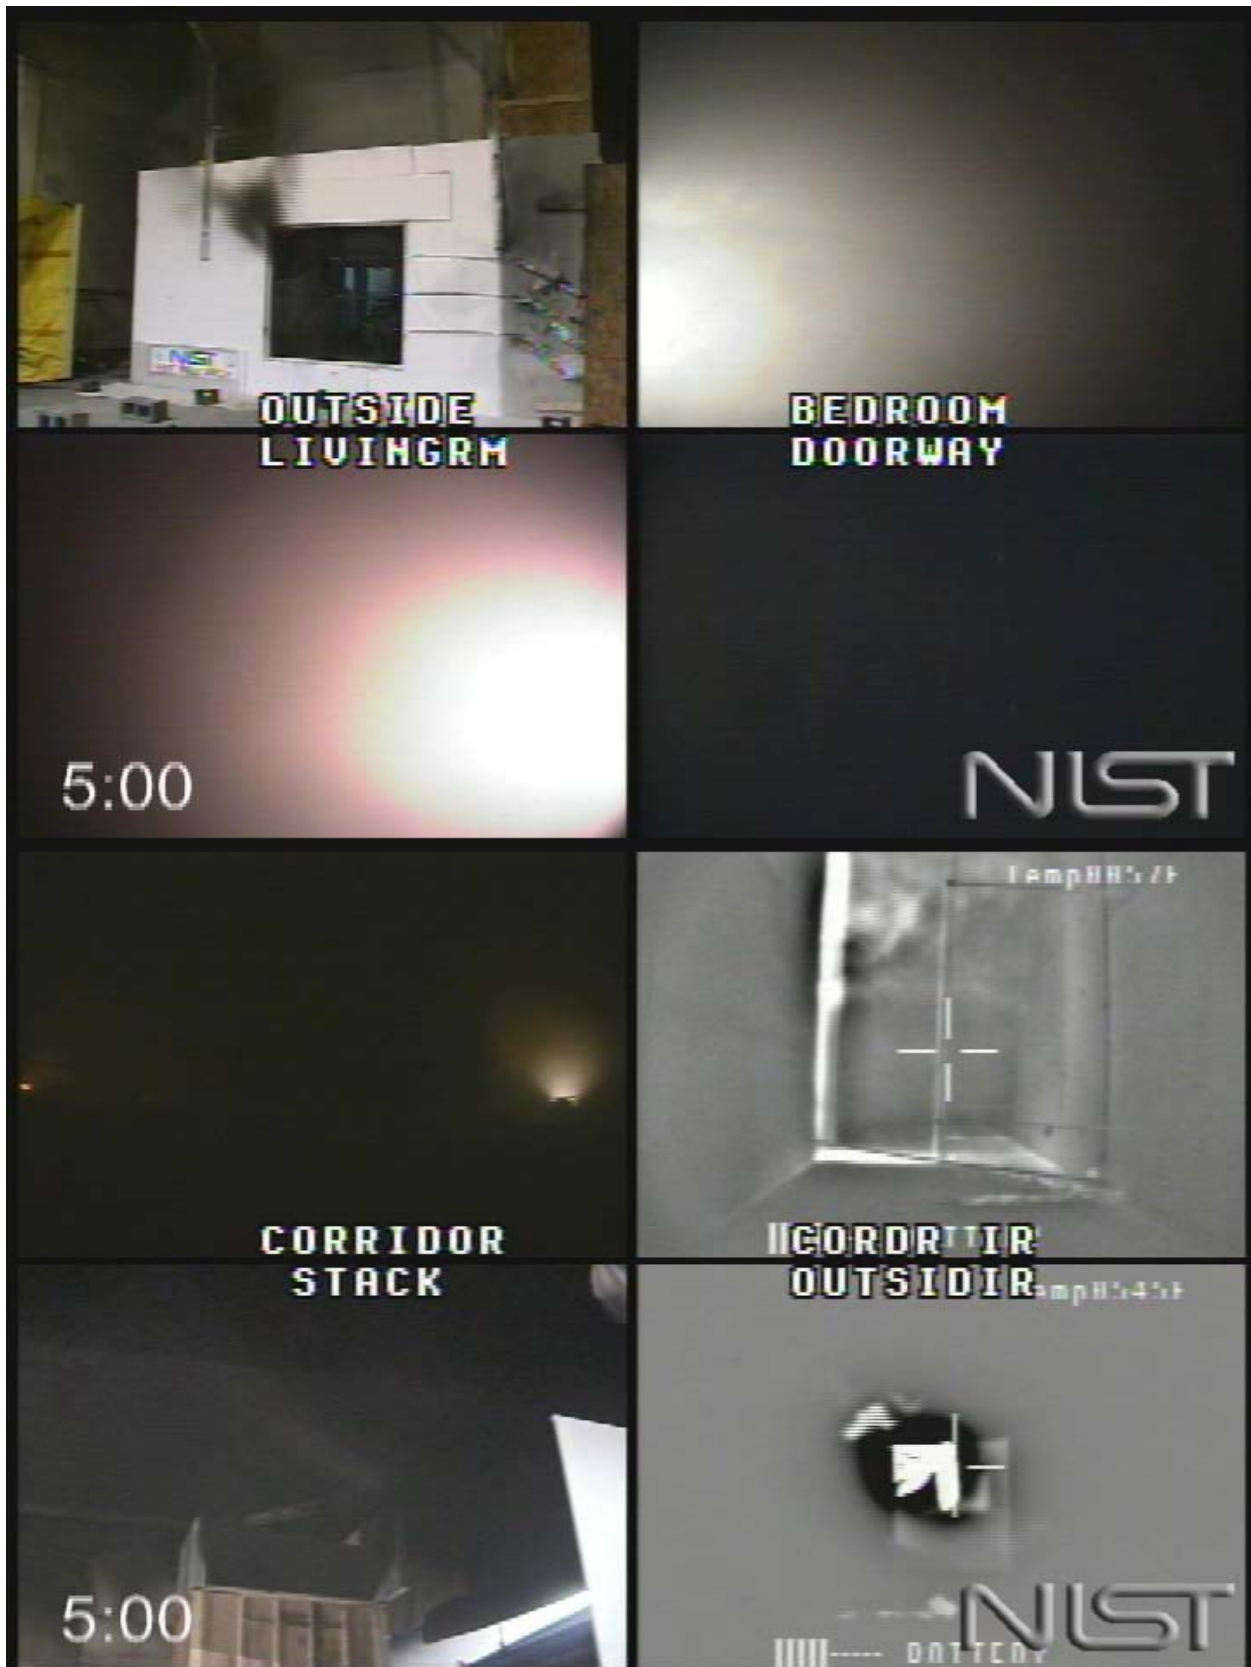
Figure 5.7.1-6. Experiment 7, 300 s after ignition.

Figure 5.7.1-6 shows the images at 300 s after ignition. The smoke layer descended to the floor in most of the structure. The corner of the window had cracked and fell out. There was an increase in the amount of heat entering the corridor through cracks around the door and the visibility in the corridor was diminishing. Light smoke was visible from the stack.

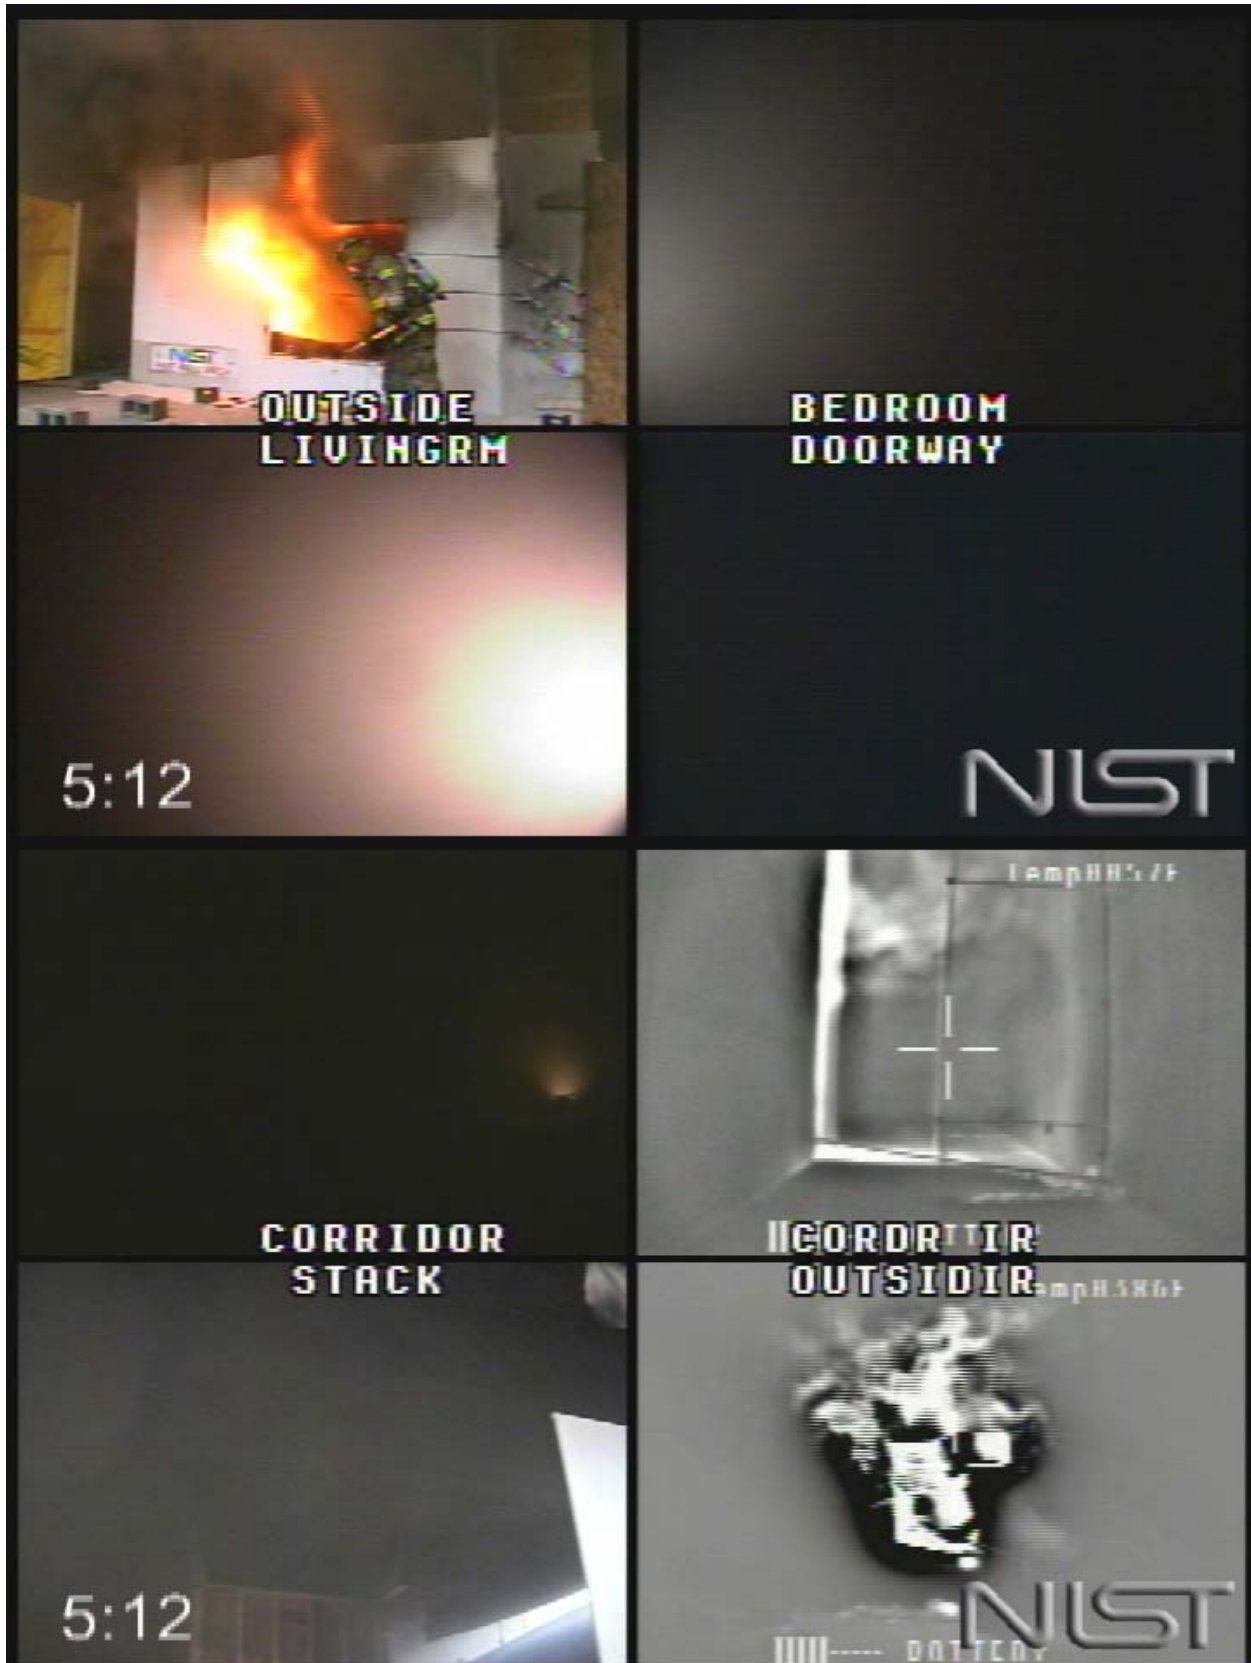
Figure 5.7.1-7. Experiment 7, window fully vented, 312 s after ignition.

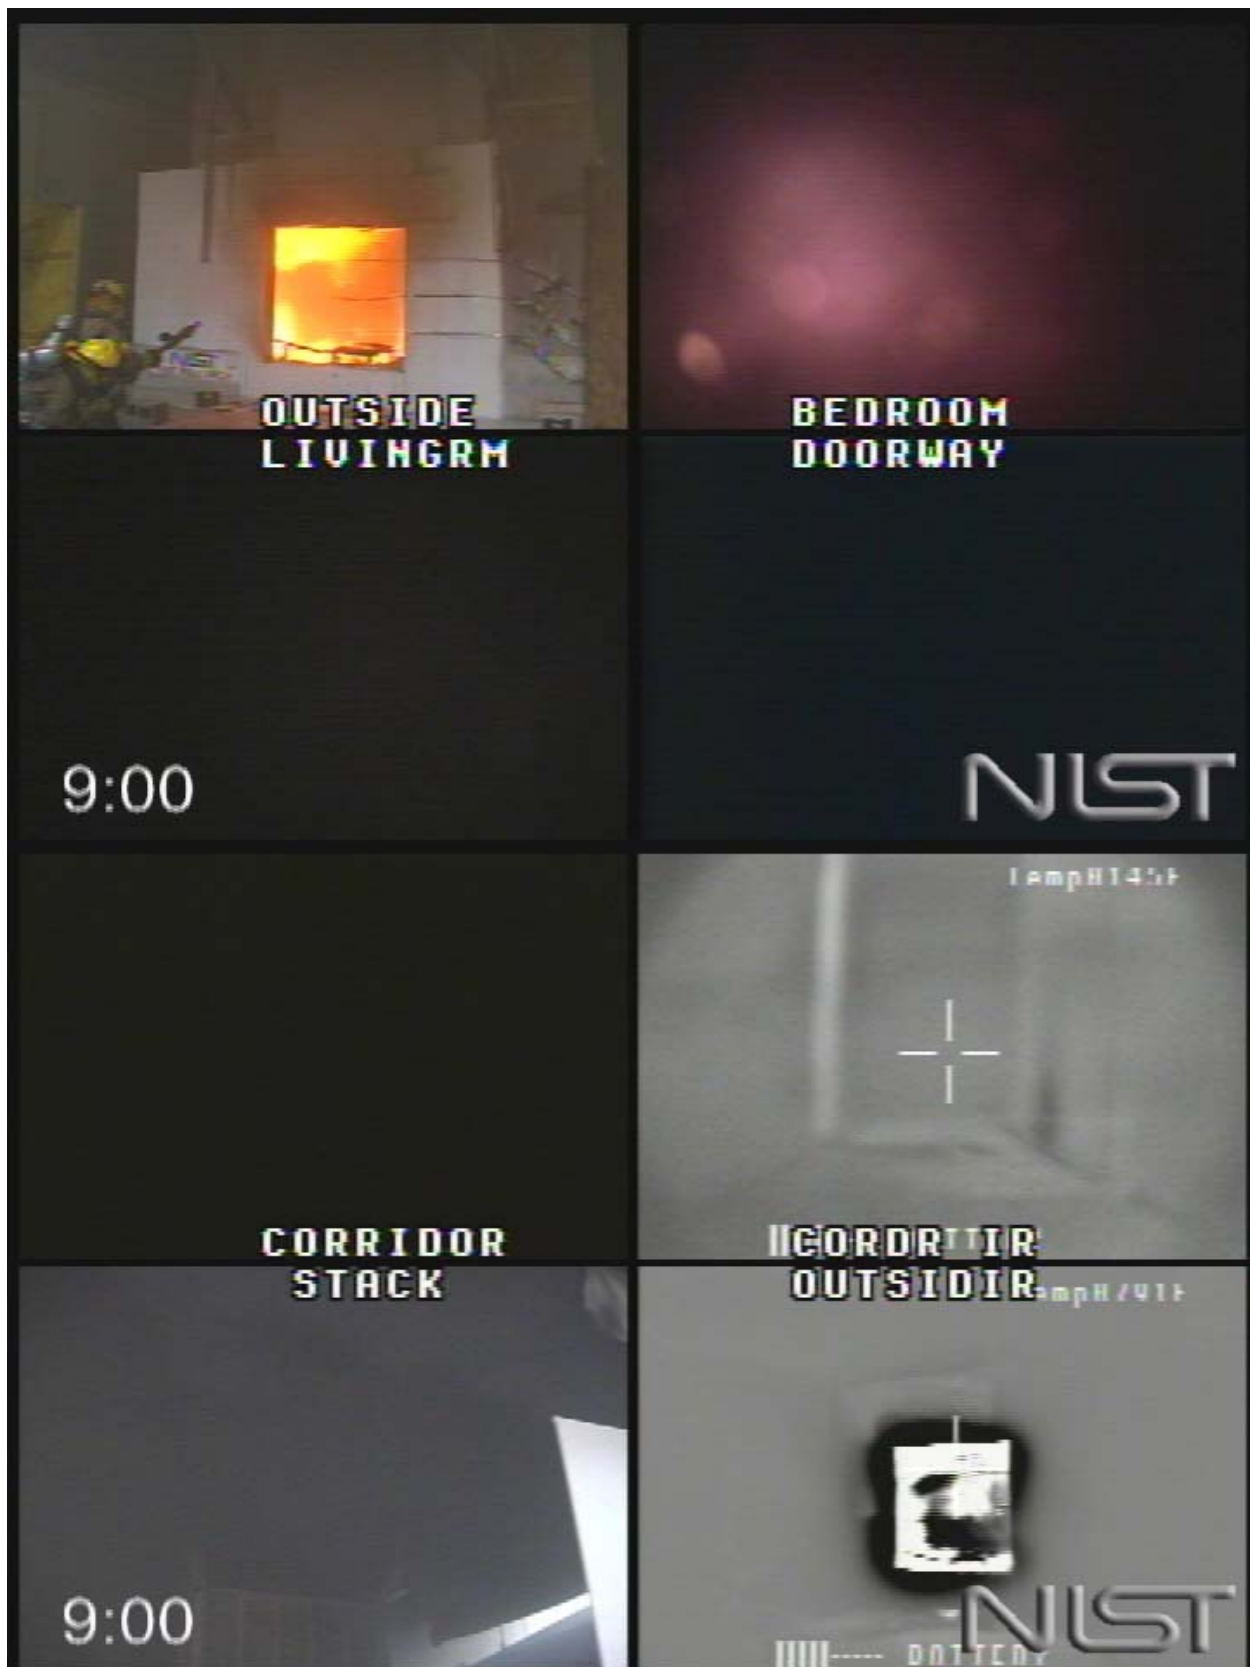
Figure 5.7.1-12. Experiment 7, 540 s after ignition.

Figure 5.7.1-12 shows the conditions at 540 s after ignition, which was about 2 s after the hose stream was turned off. Flames are still visible in the bedroom, but not coming out of the bedroom window. The internal views are still obscured but the thermal imaging view in the corridor has returned to a usable image showing little heat flow. The dark spots on the wall and floor also indicate that water made it to the corridor. The stack was once again visible showing a reduced smoke production rate.

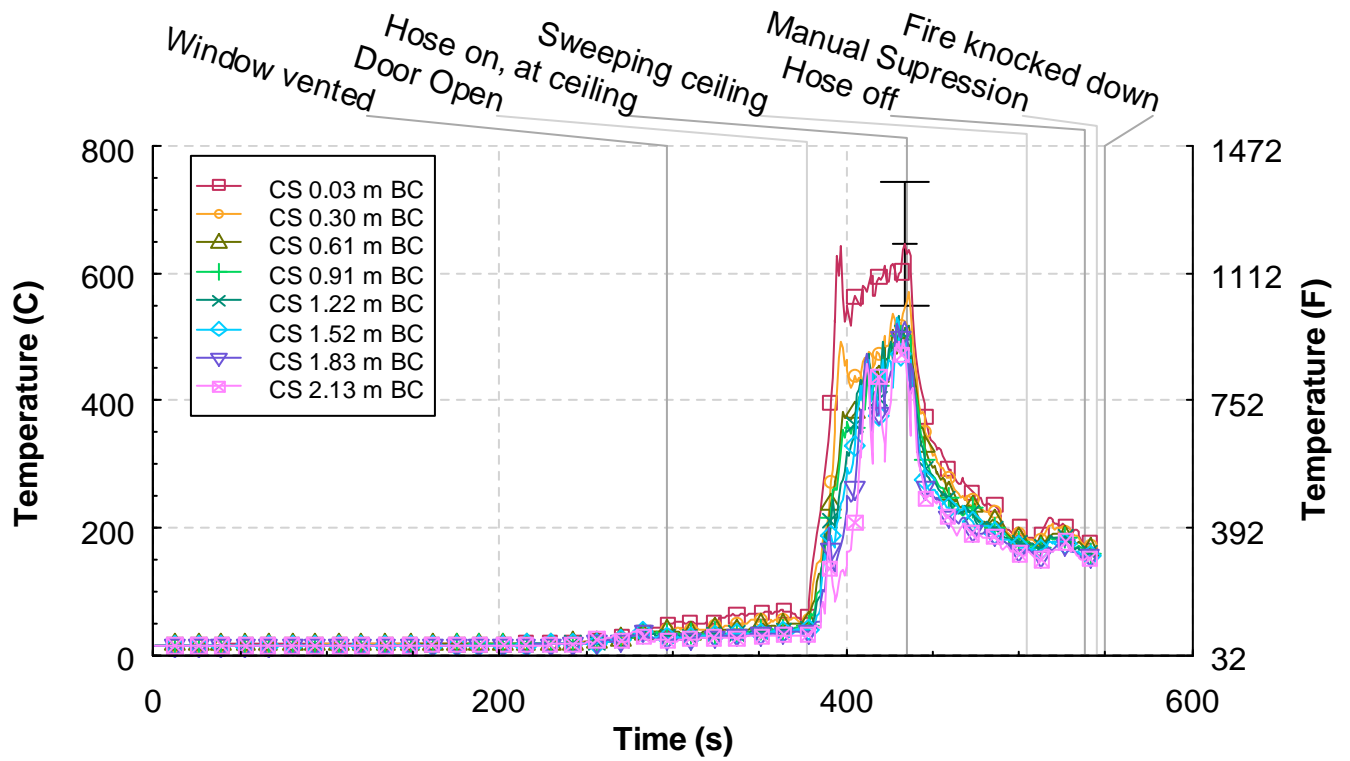
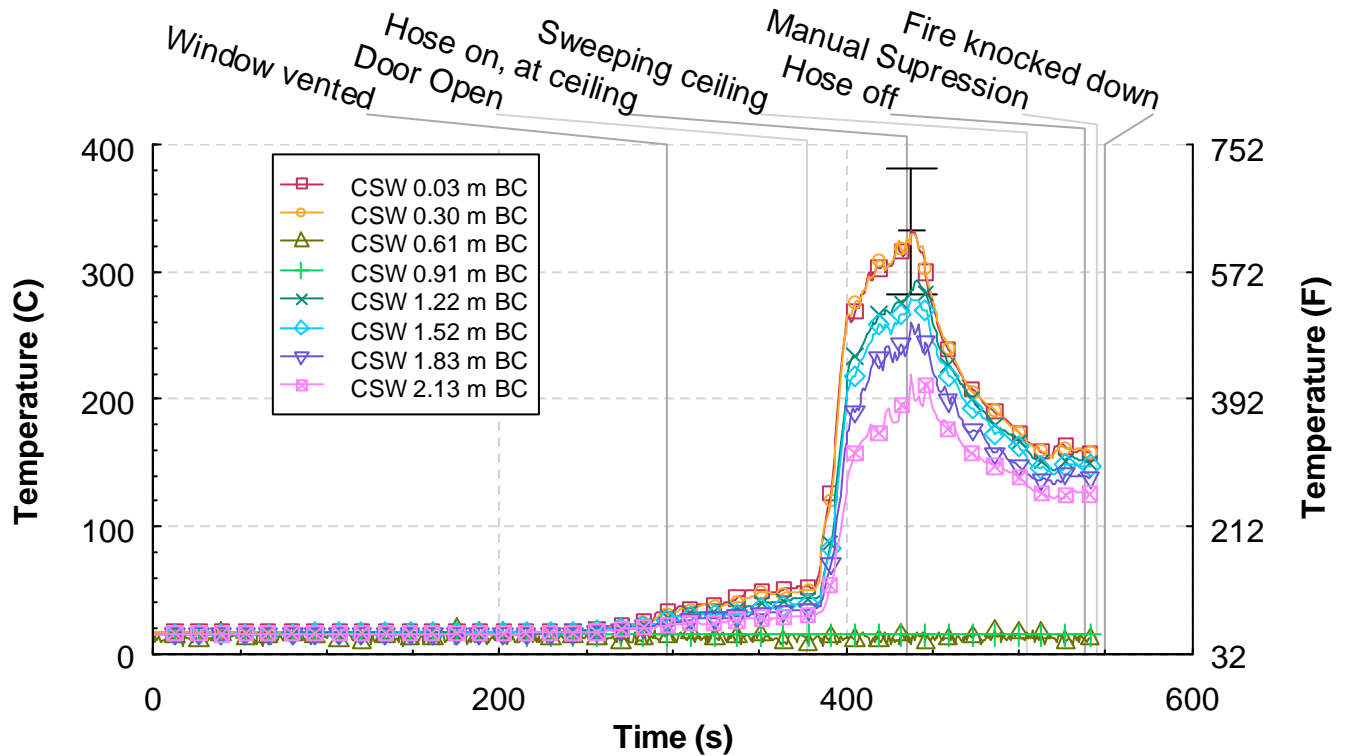
Figure 5.7.3-6. Temperature versus time from the corridor center (CC) thermocouple array, Experiment 7.

Figure 5.7.3-7. Temperature versus time from the corridor south (CS) thermocouple array, Experiment 7.

Figure 5.7.3-8. Temperature versus time from the corridor southwest (CSW) thermocouple array, Experiment 7.

Figure 5.7.3-9. Temperature versus time from the corridor north (CN) thermocouple array, Experiment 7.

Temperature conditions in the corridor are given in Figure 5.7.3-6 through Figure 5.7.3-9. The four thermocouple arrays located just outside the doorway from the living room all elevated very quickly after the door was opened. The conditions for the center and north corridor reacted in very similar fashion following the initial temperature spike in that both ceiling levels peaked at 700 °C (1472 °F) and then decreased to approximately 700 °C (1292 °F) within 10 s. The lower levels of both regions continued to increase in temperature until meeting a close equilibrium with the respective ceiling temperatures. Further, both center and north corridor temperatures sharply decreased when the hoseline opened up and continued to do so through the remainder of the test. The south corridor recorded similar temperature conditions when compared with the center and north regions. However, instead of equalizing with the remainder of the room after the initial temperature spike, the ceiling temperatures reduced in value and then increase back up to a peak of 650 °C (1202 °F). The implementation of the hose stream equalized and sharply reduced all the values. The southwest corridor recorded significantly lower values because it was positioned out of the flow path of the products of combustion. Temperatures in that region increased quickly for the first 10 s after the door was opened, but slowed in progress and did not peak to 320 °C (608 °F) for 40 s following the door opening. The thermocouple positioned 0.61 m (2.00 ft) below the ceiling malfunctioned and remained at ambient temperature throughout the test.

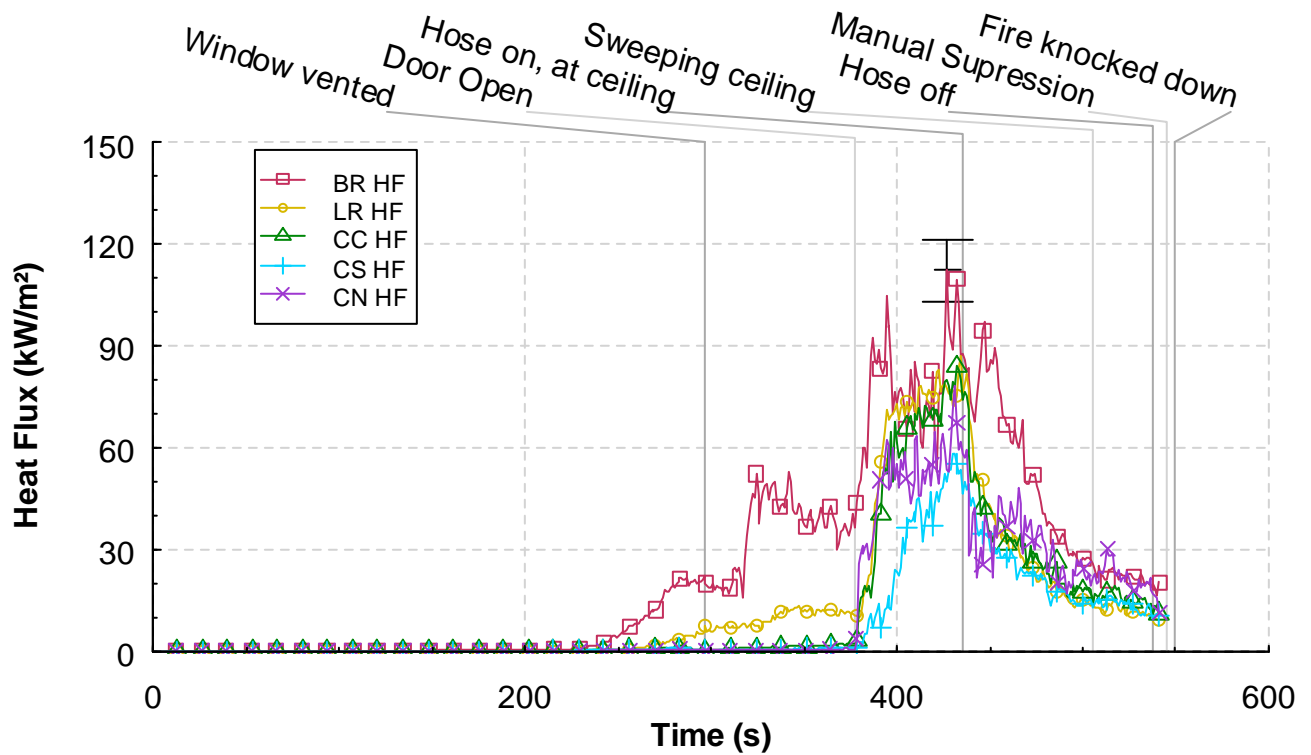
Figure 5.7.4-1. Heat flux versus time at five locations, Experiment 7.

The time history from all five heat flux gauges is given in Figure 5.7.4-1. The heat flux in the bedroom increased to approximately 25 kW/m^2 prior to the window failure. After the window vented, the bedroom heat flux increased to approximately 40 kW/m^2 but remained relatively constant and the living room heat flux increased to approximately 10 kW/m^2 until the door was opened. After the door was opened, the bedroom peaked to 110 kW/m^2 while all other levels topped 60 kW/m^2 . When the hose stream was applied at 435 s, all heat flux values dropped at a constant rate to equilibrium at the conclusion of the test.

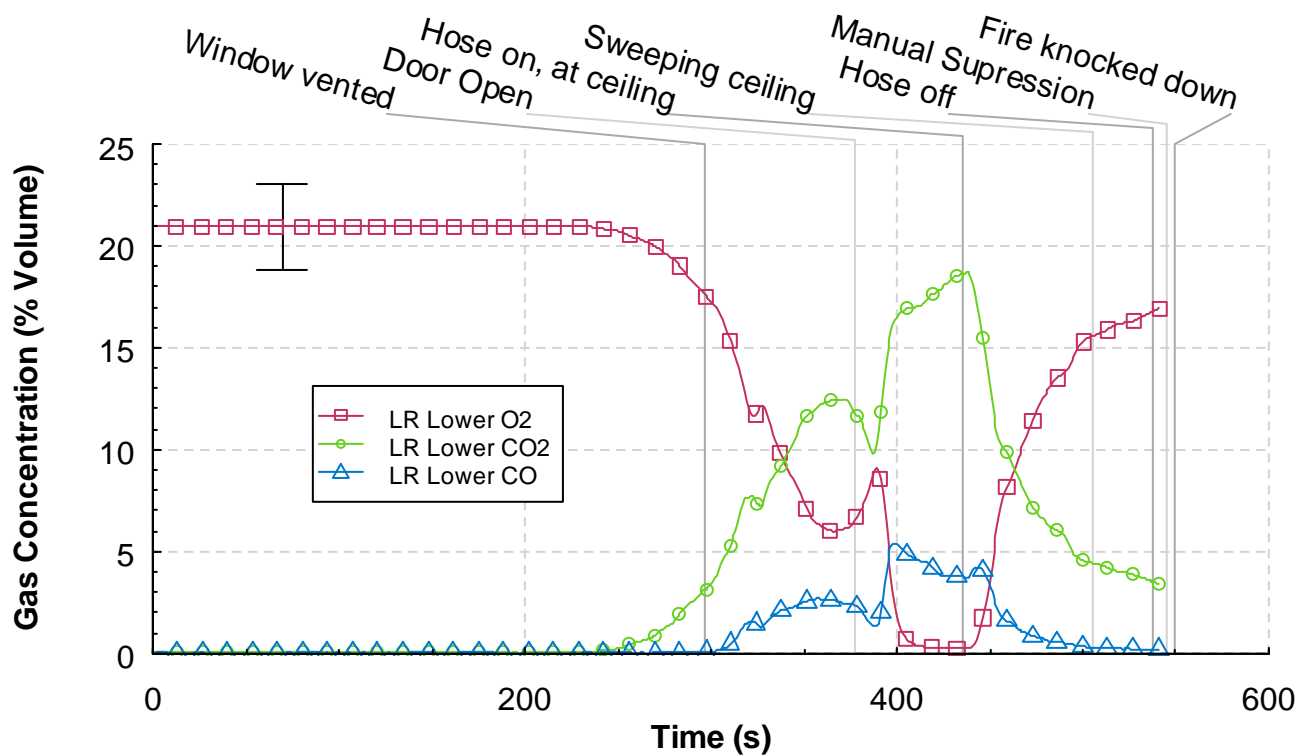
Figure 5.7.7-3. Oxygen, carbon dioxide, carbon monoxide, and total hydrocarbon percent volume versus time from the upper living (LR) room sampling location, Experiment 7.

Figure 5.7.7-4. Oxygen, carbon dioxide, carbon monoxide, and total hydrocarbon percent volume versus time from the upper living (LR) room sampling location, Experiment 7.

Figure 5.5.7-3 and Figure 5.7.7-4 provide the measurements from the upper and lower gas sampling probes, respectively, in the living room. The magnitudes and trends of the living room gas concentrations are very similar to those of the bedroom. However, the effects from the vented window appear more gradually in the living room than they do in the bedroom and the turbulent mixture of fresh air with the hot gas layer is not as readily apparent.
